Conservation & Management Plan

Colorado Lagoon Western Arm Natural Area

Tidal Influence
1340 E. Florida St
Long Beach, CA 90802

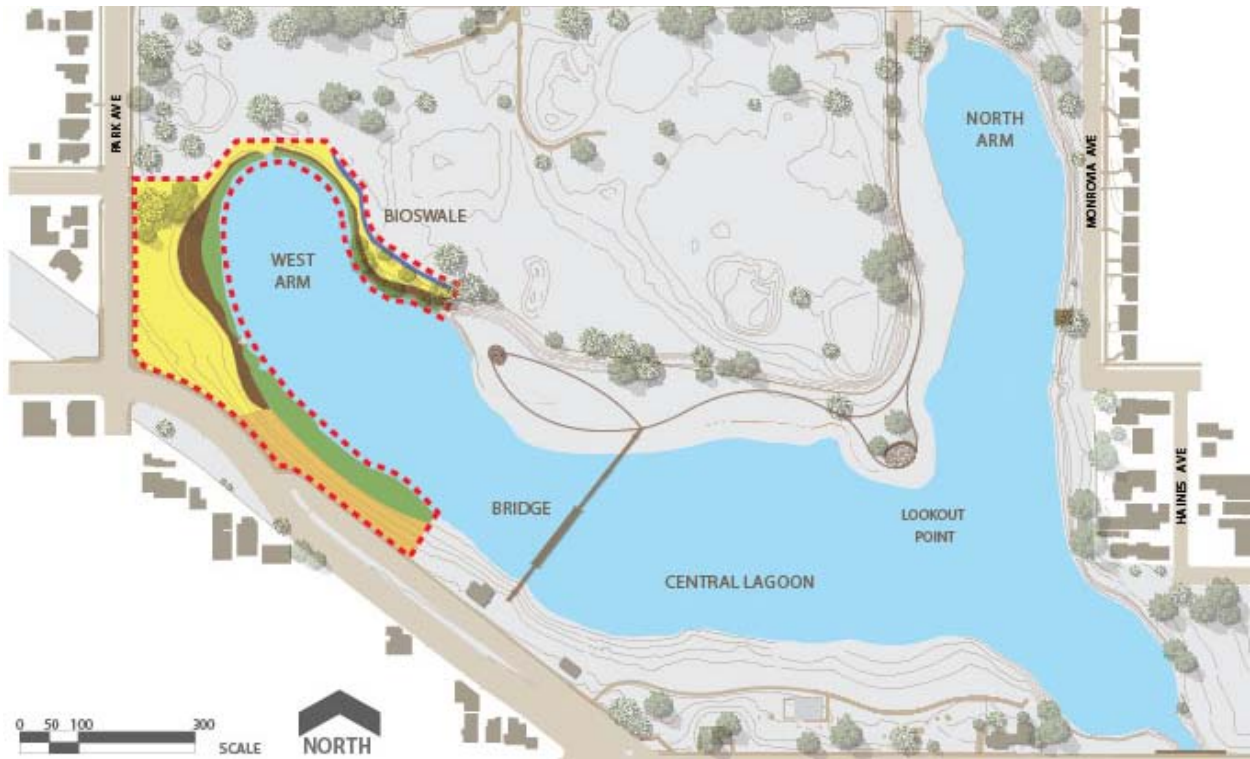
Figure 1: Map of Colorado Lagoon, highlighting the Western Arm Natural Area

The Western Arm Natural Area is located on the distal end of the west Arm of the Lagoon, easily viewed from Park Avenue and Appian Way. A detailed map of the Colorado Lagoon can found on the next page.

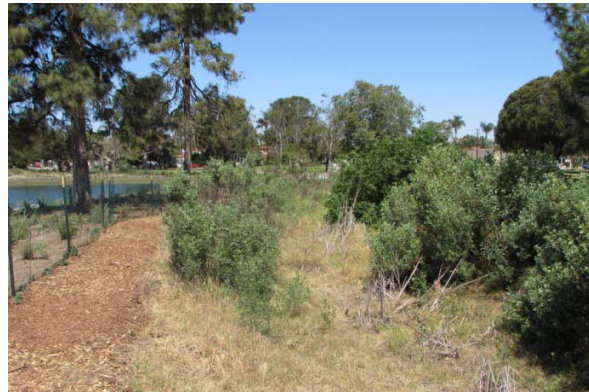
Photo 14: Bioswale on the north bank of the Western Arm. This is a seasonal wetland; note the dry *Typha latifolia* in the foreground (Graves)

A freshwater wetland is an area that consistently experiences a year-round or seasonal influx of freshwater and contains plants adapted to thrive under such conditions, such as *Eleocharis macrostachya*, *Typha latifolia*, and *Juncus acutus*. A bioswale is a human-made freshwater wetland designed to catch and filter surface water runoff. The Western Arm's bioswale takes the shape of a shallow channel running along its northern boundary; it was contoured to have gently sloping sides and to maximize the time it takes for water to run through the system. The root systems of plants in this habitat uptake and break down many pollutants found in runoff water, preventing contaminants from affecting the Colorado Lagoon's water quality. In the Western Arm, the bioswale exists as a mixture of native and non-native species.

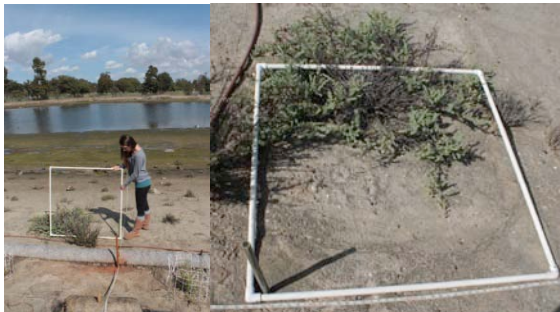
Photo 66: Step 5 (Tidal Influence)

1. Collect materials (2 pencils, 1 clipboard, 1 rubber band, hard copy of previous month's data, 6 blank data sheets, 1 square meter quadrat, 1 transect tape, 1 camera, 1 meter stick)
2. Fill out top portion of "Colorado Lagoon Vegetation Field Sampling Data Sheet"
3. At the first transect in the Western Arm, extend transect tape down to 1m past the last quadrat marker. Align the transect tape so that it touches both PVC pipe markers (Photo 63).
4. Take 2 pictures - 1 landscape and 1 portrait (Photo 64, 65) – from the top of the transect facing the water.
5. While facing the transect tape, place the PVC quadrat square on the ground with the quadrat marker (PVC pipe) resting in the bottom left hand corner of the quadrat (Photo 66).

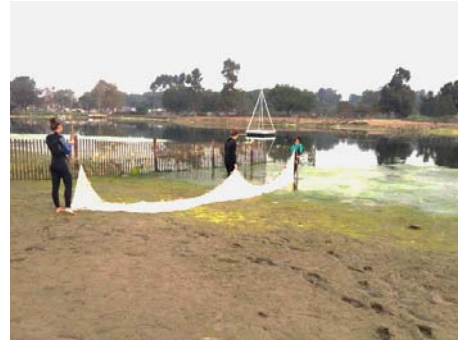
Photo 69: Step 5 (Tidal Influence)

5. Place 1 person at each end pole. Walk the net into the water, orienting the net perpendicular to the shore (Photo 69).
 - a. Poles must maintain contact with the ground for the entire seine.

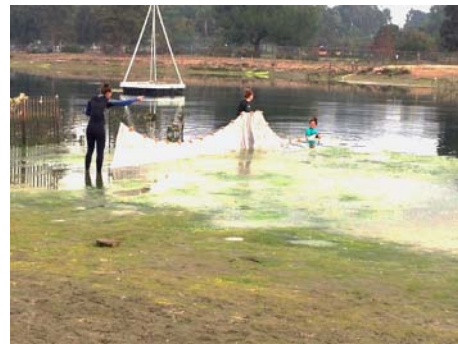
Photo 70: Step 5.b (Tidal Influence)

- b. The lead individual will walk straight out into the water until they reach the deepest point where they can comfortably walk along the bottom of the Lagoon (Photo 70).

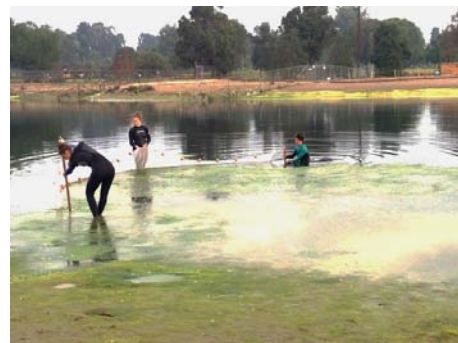
Photo 71: Step 5.c (Tidal Influence)

- c. Lead individual walks parallel to the shore for 5 to 10 feet. The trailing pole will also walk along the shore for the same distance (Photo 71).
 - d. Once the walking distance has been reached, the trailing individual stops walking while the lead individual swings the net toward the shore (Photo 72). Keep the net at full, extended length during this time.

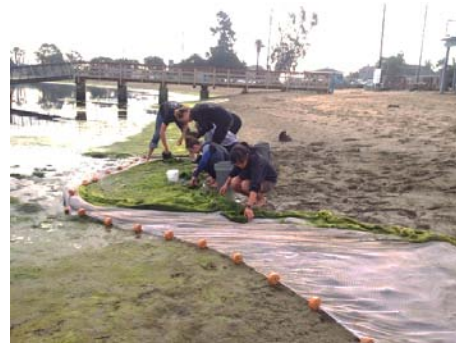
Photo 73: Step 6 (Tidal Influence)

6. Once on shore, flatten net on the ground and collect all organisms, placing them in buckets containing salt water (Photo 73). Search algae for hidden fauna.

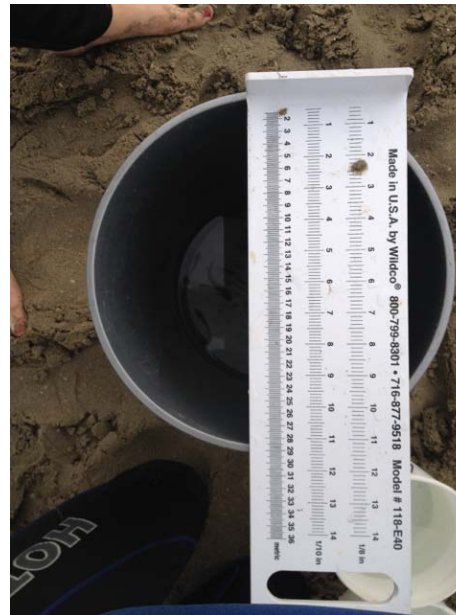
Photo 74: Step 7 (Tidal Influence)

7. Once all fish are collected from the net, begin measuring the length in centimeters of ten individuals per species. Use the measuring board over a water bucket (Photo 74).
8. After 10 individuals per species are measured, continue to count the number of individuals per species.
9. After all of the organisms have been measured and/or counted, gently empty buckets back into Lagoon.
10. Carry the net to the water (keeping it flat), and clear away any algae.
11. Carry materials to the next sample location and repeat steps 1, 3-10.

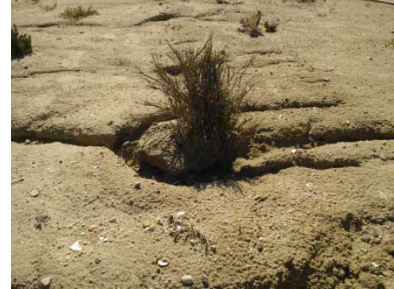
Photo 75: Evidence of erosion around an established plant (Graves)

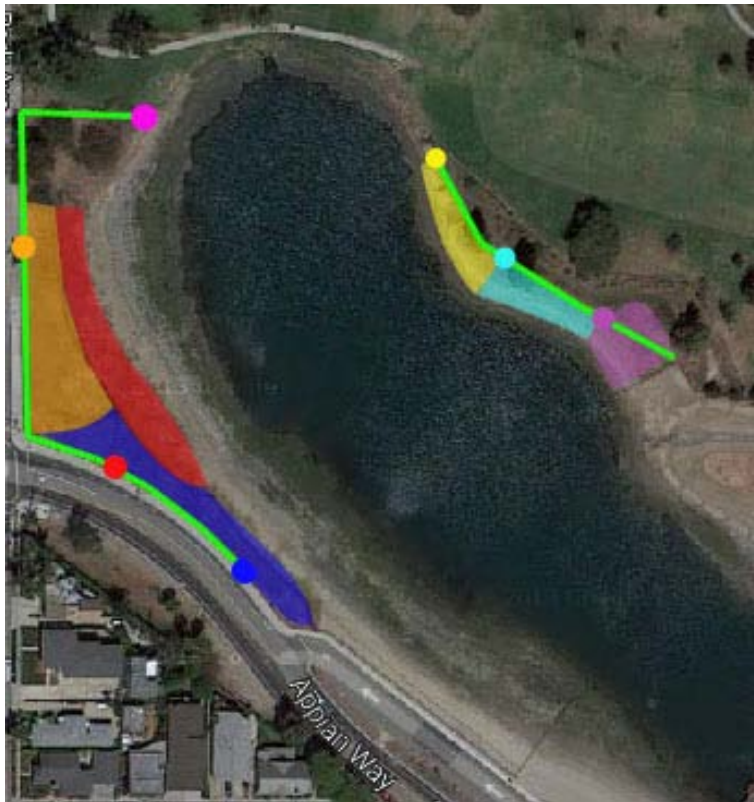
Figure 3 (left) is a map of all valve locations and main irrigation lines. The purple dot in the upper left hand corner is the main control valve for all irrigation lines in the Western arm. All other dots on the site represent secondary control valves; the correlating color blocks represent the habitat area covered by this control valve. The green line is the main pipe; this line is under constant pressure unless the primary valve (purple) is closed. Quick connectors for hose hook ups are located intermittently along the length of these lines.

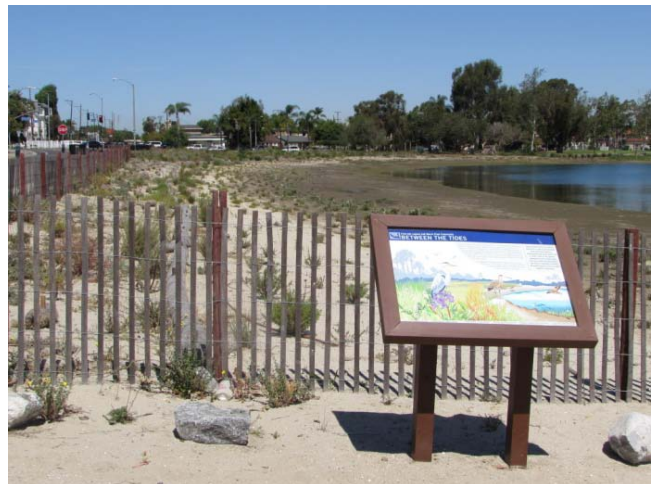
Kiosk structures can be partially disassembled by removing two crews and detaching the top section of the frame. The metal signs are double sided; if signs are defaced, they can be flipper for a fast solution. If additional maintenance is required, Friends of Colorado Lagoon should be consulted.

Photo 76: Educational kiosk outside the Western Arm Natural Area boundary (Graves)

- On the southeastern fenceline (Photo 76)
- Next to the lifeguard tower
- Adjacent to the bridge
- On the corner of Appian Way and Park Avenue
- Near the Men's tee box of the Little Rec 7th Hole

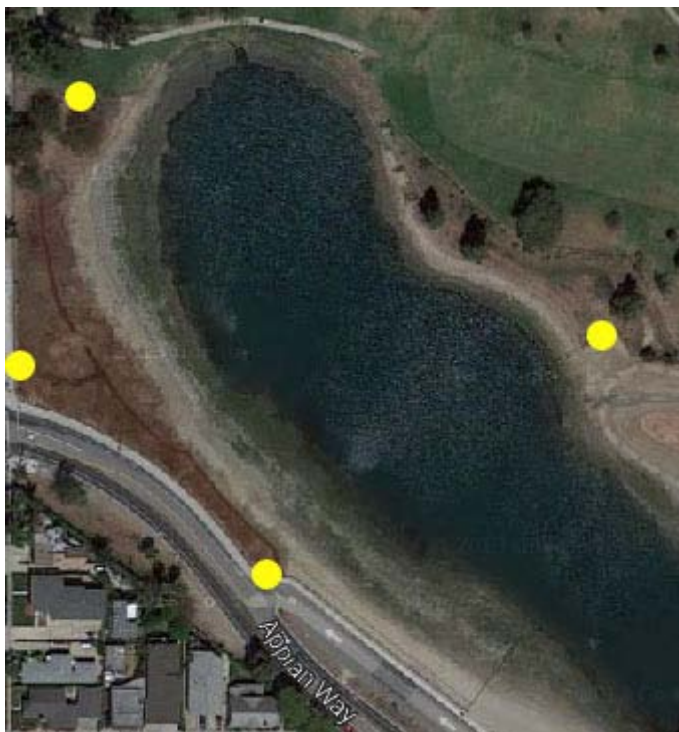
Figure 5: Map of Access Points to the Western Arm

Four gates are installed in the fenceline surrounding the Western Arm Natural Area to provide easy access to all restoration areas. Gate locations are depicted by yellow dots on the figure below. All gates are accessible using a City of Long Beach 6-key.

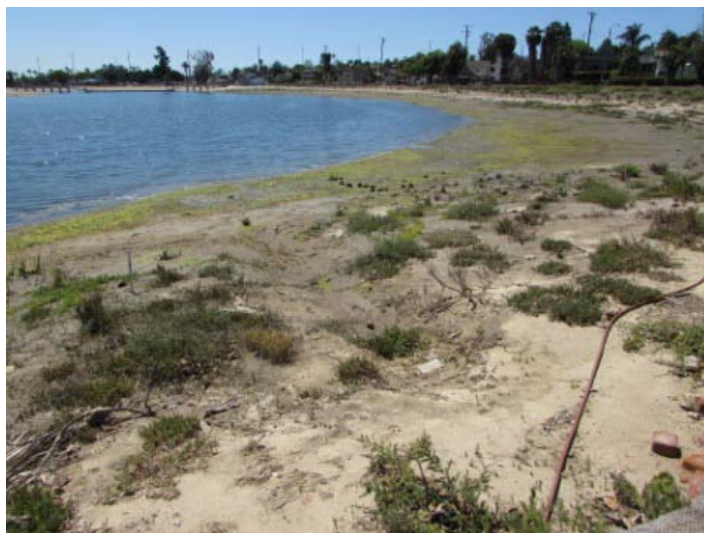
Photo 77: Erosion blow out in the salt marsh on the western point (Graves)
